**ACF INDUSTRIES  
CSM Site Summary**

**ACF INDUSTRIES**

Oregon DEQ ECSI # 794

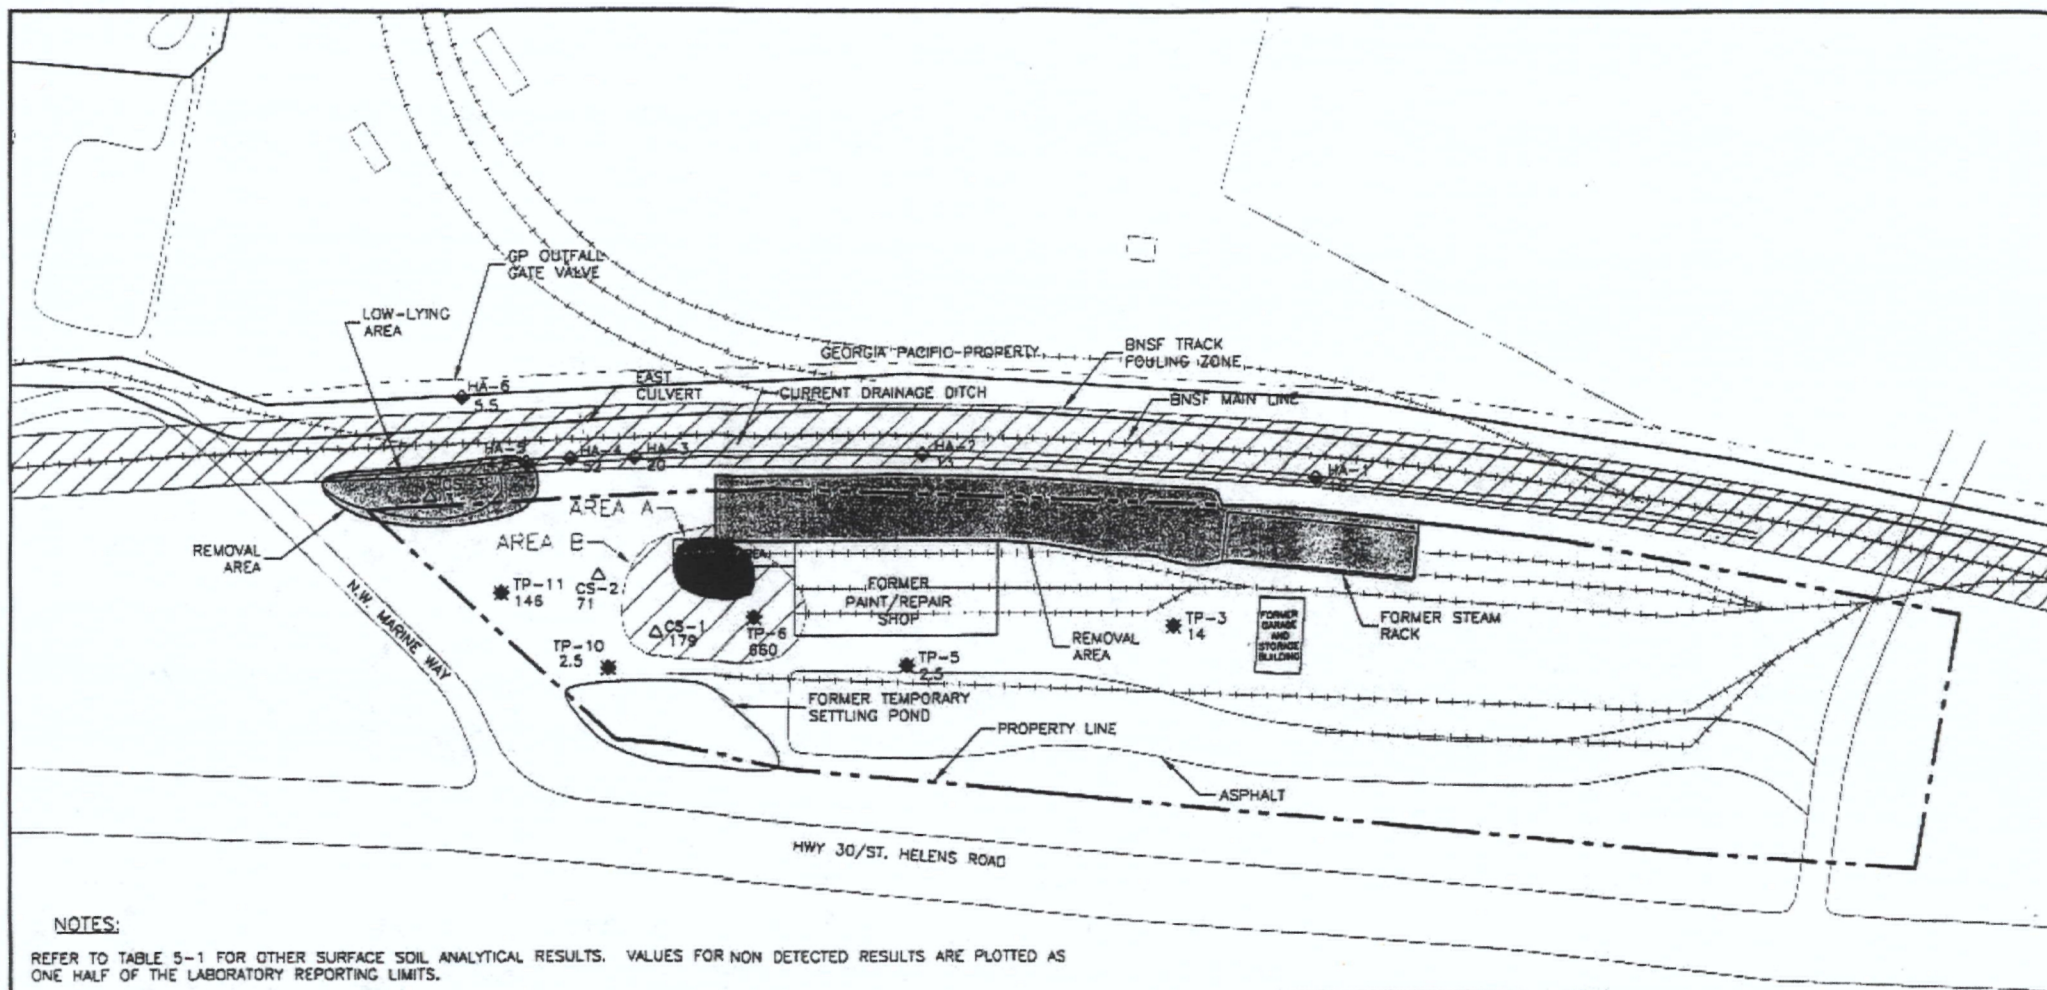
Figure 5-1. Surface Soil Locations and Measured Arsenic Concentrations (RETEC 2002)

Potential upland sources include possible contaminated soils remaining on the property. Areas A and B [see Supplemental Figure 5-1 from RETEC (2002)] contain elevated arsenic concentrations in soil (discussed further in Section 10.1). Elevated concentrations in Area A would be considered a hot spot under Oregon soil cleanup standards.

Surface soils in the vicinity of the paint shop blasting area were found to contain elevated concentrations of arsenic. The concentration of arsenic detected in Area A (see Supplemental Figure 5-1) was high enough to exceed DEQ hot spot standards for existing site conditions. Arsenic concentrations generally decreased with depth and distance from the former paint shop sand blasting area. Concentrations of all analytes, including arsenic, were below screening level values in ditch soils adjacent to the GP outfall, indicating that stormwater runoff from the ACF site is not a significant source of contamination to the Willamette River (RETEC 2002).
